Technical Report 1617
September 1993

**VLF Harold E. Holt
RADHAZ Measurements**

P. M. Hansen
NCCOSC RDT&E Division

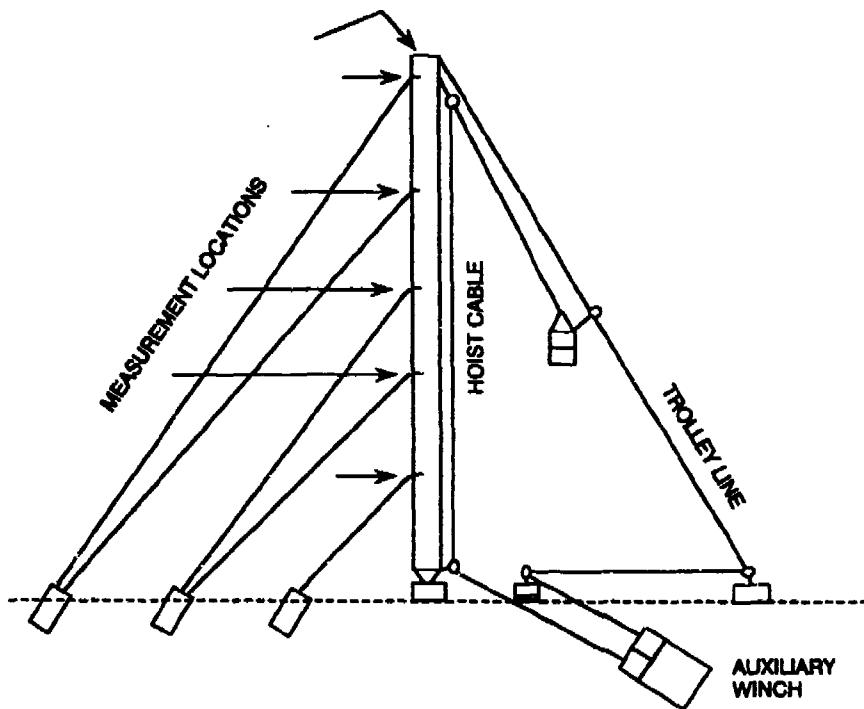
Figure 4. Typical tower guy system and auxiliary winch rigging.

The towers that hold up the top-load are all grounded and have grounded guy wires (figure 4). The towers and guy wires shield the ground area around the tower bases so that the average field in these areas is very low.

The maximum electric fields are outside the tower in the tower top area above the top guy wire. For a tower with an active panel attached, these fields are several kV/m.

The conclusion of the above discussion is that areas exist on the ground around the transmitter building and at the tower tops where the electric fields are expected to exceed the 614 V/m limit.

The typical rigging for the auxiliary winch and bucket hoist is shown in figure 4. The winch uses two separate drums. One drum hauls the hoist cable that lifts the bucket; the second drum controls the trolley-line tension that guides the bucket and keeps it tagged out from the tower. The entire loop is grounded by a good ground connection at the winch.

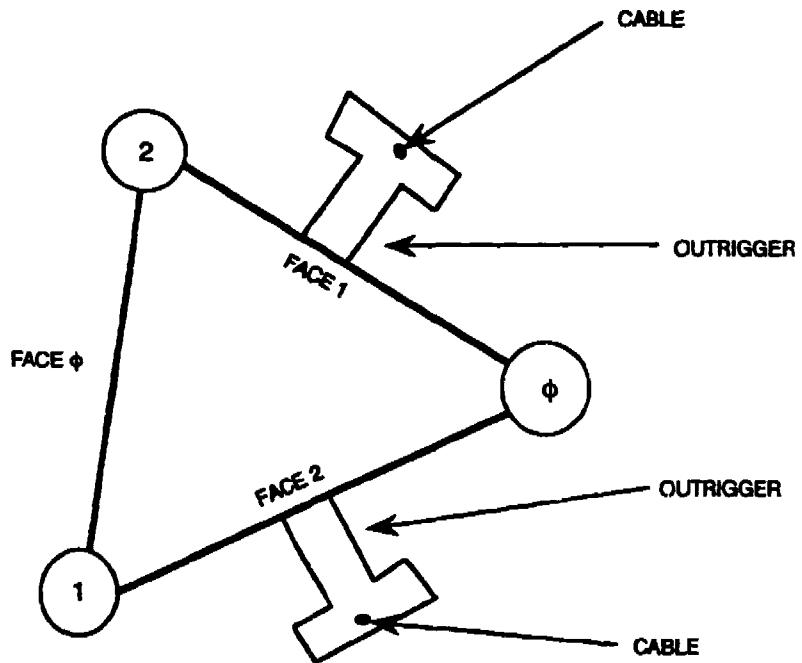
Figure 5. Top view inner tower.

The inner towers are placed such that the 0 face is on the side away from T0 (figure 5). The inner towers have two winches at the base. The winches are connected to the two hoist cables for the panels on either side of the tower. These hoist cables run up the outside of the tower in the center of faces 1 and 2. The hoist cables are held off from the tower by several outrigger arms, which are about 6 feet long near the bottom of the tower and about 2 feet long near the top.

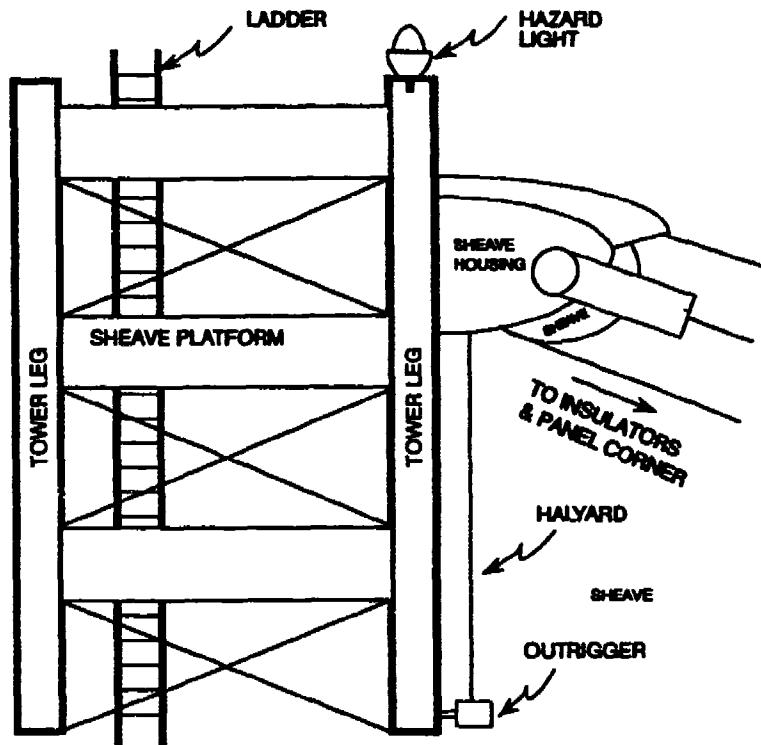
Figure 6. Tower top area.

The section at the tower top, the sheave platform (figure 6), is where the hoist sheaves are located. Much of the tower maintenance work is performed here. The sheaves extend out from the center of panels 1 and 2. Measurements were done at the platform center and at several locations outside the tower, including on top of the tower. These locations, most of which are indicated in figure 6, are accessed by riggers for maintenance.

locations where the fields exceed the 614 V/m limit are where the field is concentrated by a sharp edge such as a ladder top or edge of the sheave housing. Even though the fields exceed the limit in a local area, averaging over the extent of a person's body, as specified by the standard, indicates that there is no hazard. Body currents were measured at all working locations indicated by the riggers on the isolated tower. No significant body currents were measured.

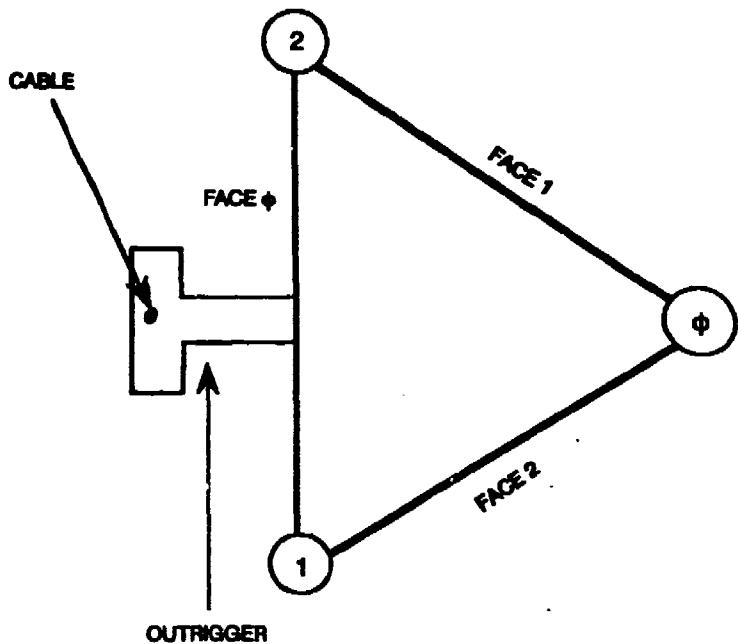
Figure 7. Top view of outer tower.

The outer towers are placed such that the 0 face is on the side towards T0 so that the single sheave at the top of an outer tower is pointing at T0 (figure 7). The outer towers have a sheave platform similar to the inner towers but with only one sheave.

The outer tower only has one winch at the base. The winch connects to the hoist cable going up the 0 face to the sheave. Like the inner towers, the hoist cable is held off from the tower by several outrigger arms.

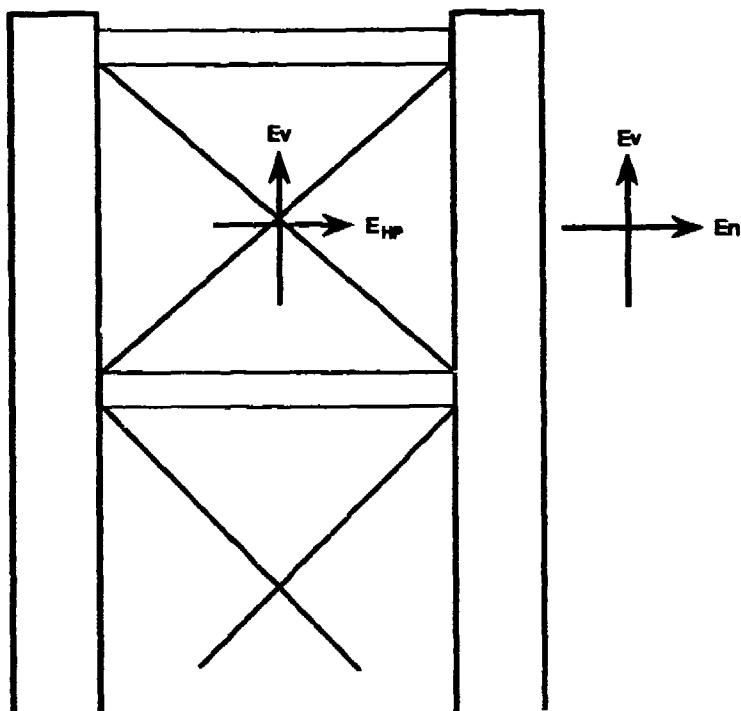
Figure 8. Field polarizations measured.

In the 6-panel mode at maximum power, the electric field levels outside the tower at locations above the first guy level were well above the limit set by the standard. For example on the inner tower T2 (table 3), E_n (figure 8) on face 0 of T2 exceeded 1000 V/m at all locations measured. The fields on the tower top were very high; about 8000 V/m in some cases. At levels below the first guy, the fields outside the tower are below the hazard level defined by the standard.
